HAZELWOOD Community Update

Additional Mine fire pipework

Cleaning large plant in the Station

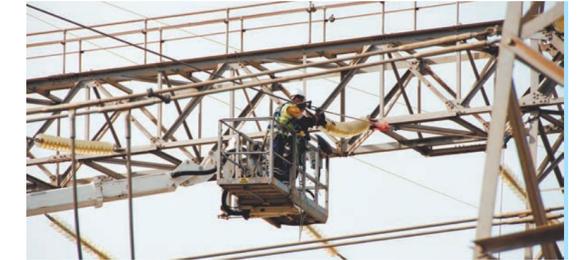
TRANSFORMER DISCONNECTION

The eight transformers, used to convert low voltage power from Hazelwood Power Station to high voltage for distribution to the grid, have been disconnected.

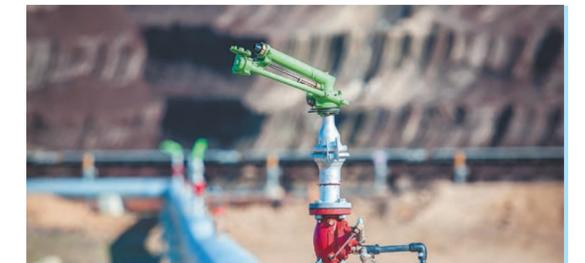
FIRE SERVICES PIPEWORK

Installation of new sections of pipe is reinforcing the existing extensive network of pipework in the Hazelwood Mine to ensure fire readiness.

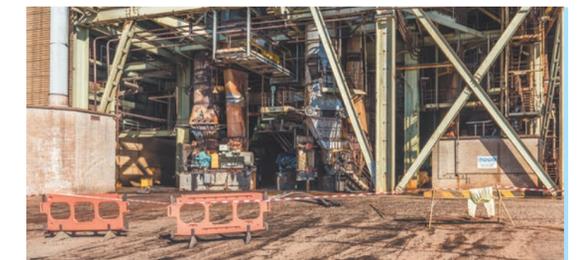
EXTERNAL PLANT CLEANING

Employees from local contractor AsClear washed the externals of the 50 metre high boilers including the roof trusses, wall cladding, beams and drains.

Employees from local contractor AsClear cleaned inside the large boilers of the station and then turned their attention to washing outside, including the roof trusses, wall cladding, beams and drains.
